Inspector's Daily Report

IDR Sheet	1	of	1	Sheets	Final Record Book	Page
Contract				Day		Date
	C-7852	si .		Т	uesday	June 7, 2011

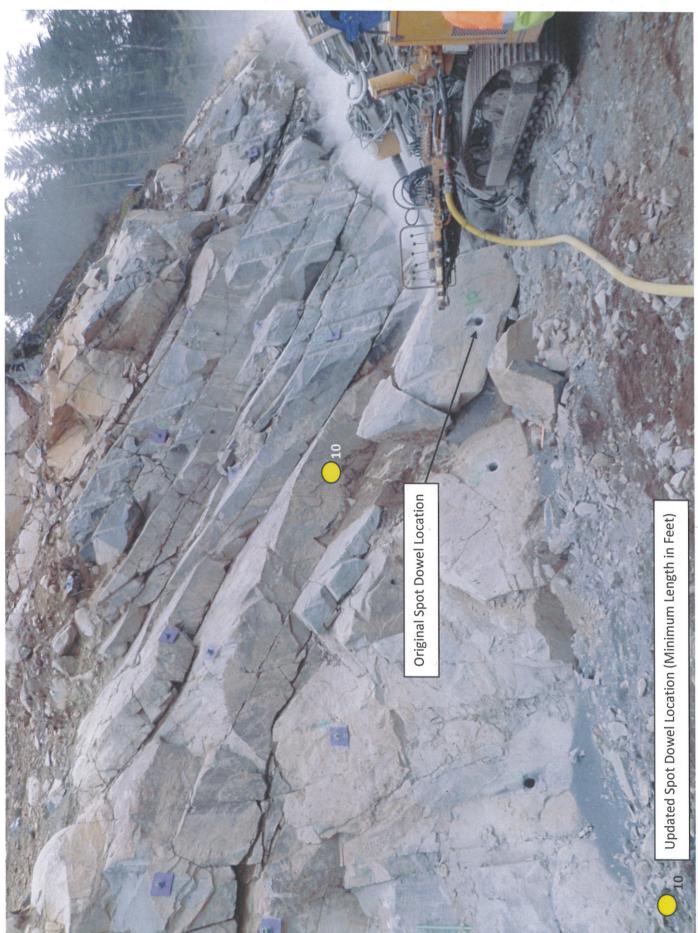
Brad Schut called and indicated that while NW Cascade was drilling one of the Type H rock dowels, located the previous day, the rock block failed and were requesting direction. I drove to the site and Brad and I relocated the dowel location to rock block behind the original location (Figure 1).

Figure 1. A photograph showing the block that filed during drilling operations and the updated spot dowel location.
